# Monitoring Slump-Earthflow Complex Movement: A Southeastern Ohio Case Study<sup>1</sup>

JON W. VAN DE GRIFF AND DOROTHY SACK, Department of Geography, Ohio University, Athens, OH 45701

OHIO J SCI 104 (5):126-135, 2004

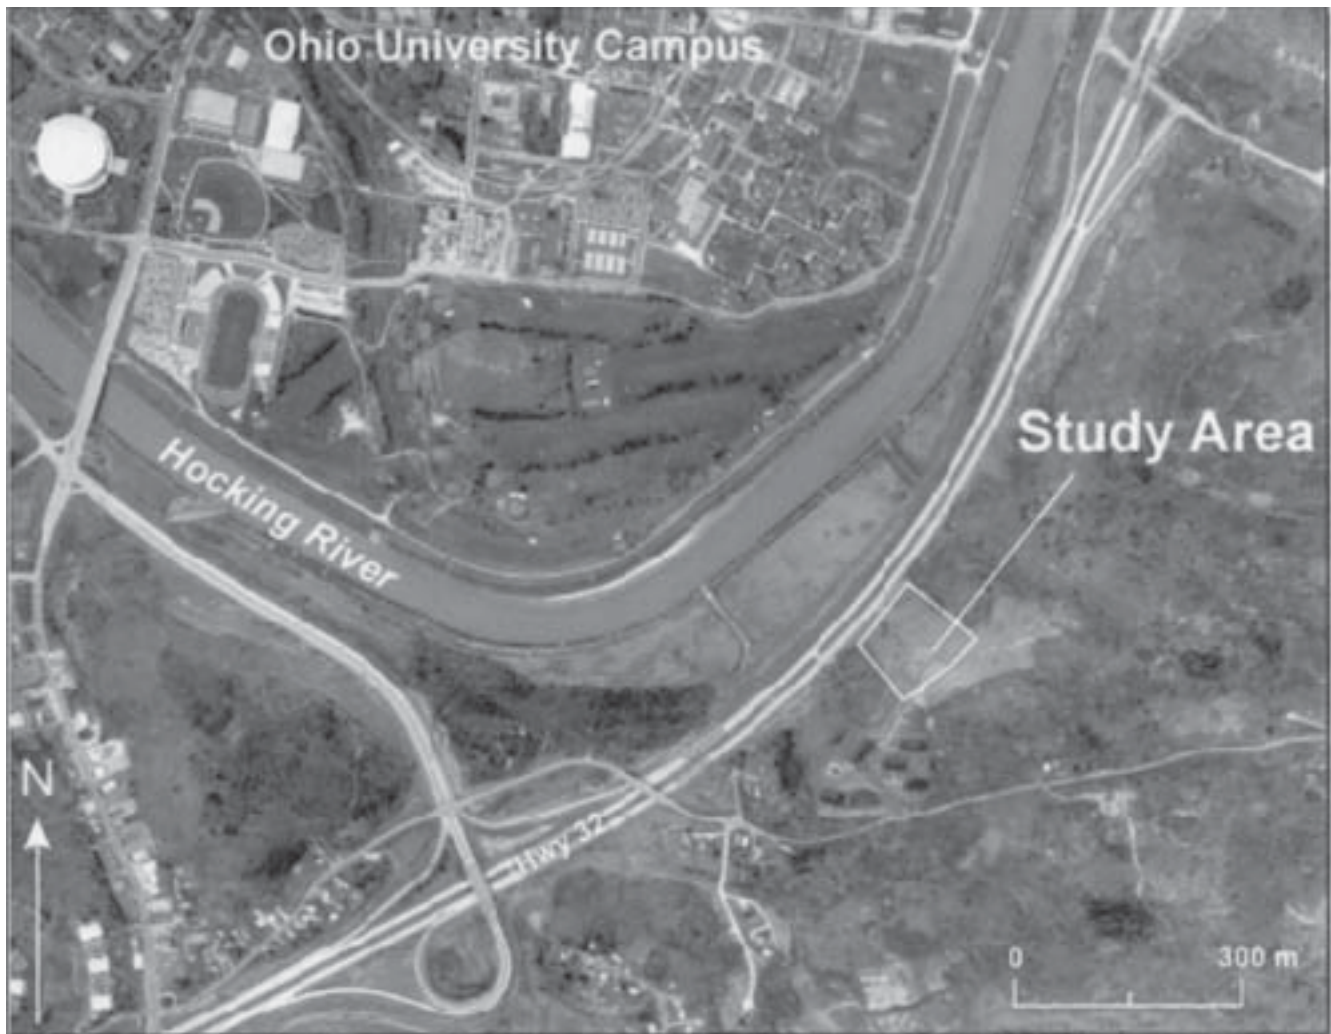
FIGURE 2. Aerial view of the slump-earthflow study and its relative location with respect to local landmarks.

The study site is a slump-earthflow complex located in the nonglaciated portion of southeastern Ohio just south of the Hocking River near the southern boundary of the City of Athens (Figs. 1,2). This slump-earthflow complex contains two major slumps, referred to as the northeast slump and southwest slump, and one major earthflow (Fig. 3). A few minor earthflows are found on the foot and crown. The study site measures 100 m wide at the toe and 113 m wide at the crown (Fig. 4). The length of the slope, from the toe through the foot to crown, is approximately 131 m as measured overland by tape. The toe is located 10 m southeast of State Route 32. The Hocking River channel lies approximately 150 m northwest of State Route 32 (Fig. 2). The State of

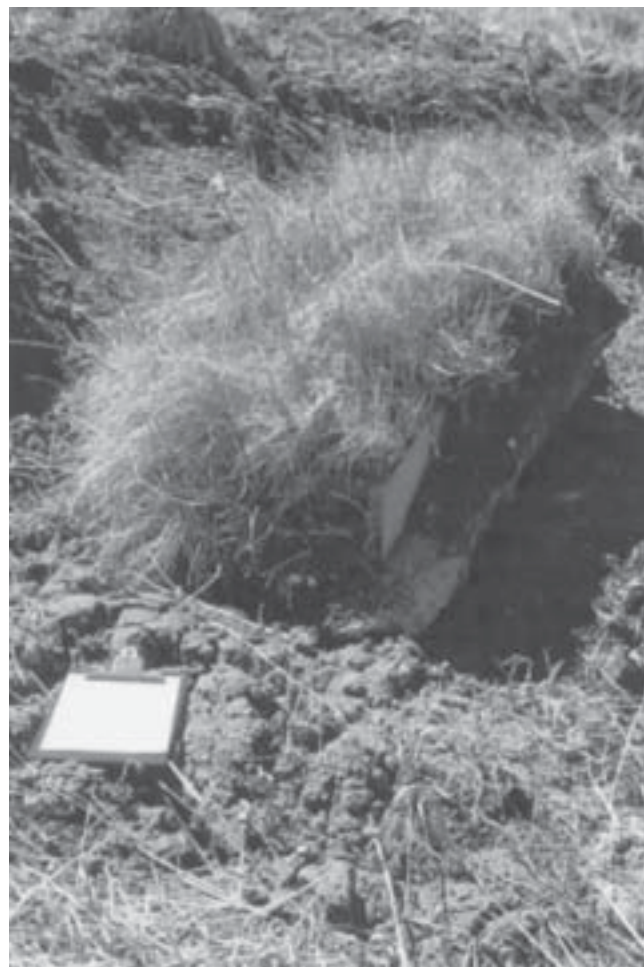
FIGURE 5. Photograph of earthflow movement that occurred during the study period (clipboard in foreground for scale).
